***Soil Contamination Risk  
Northern Overland Flow Channel  
Fill Risk Assessment***

***52 Kippenberger Avenue  
Rangiora***

*August 2021*

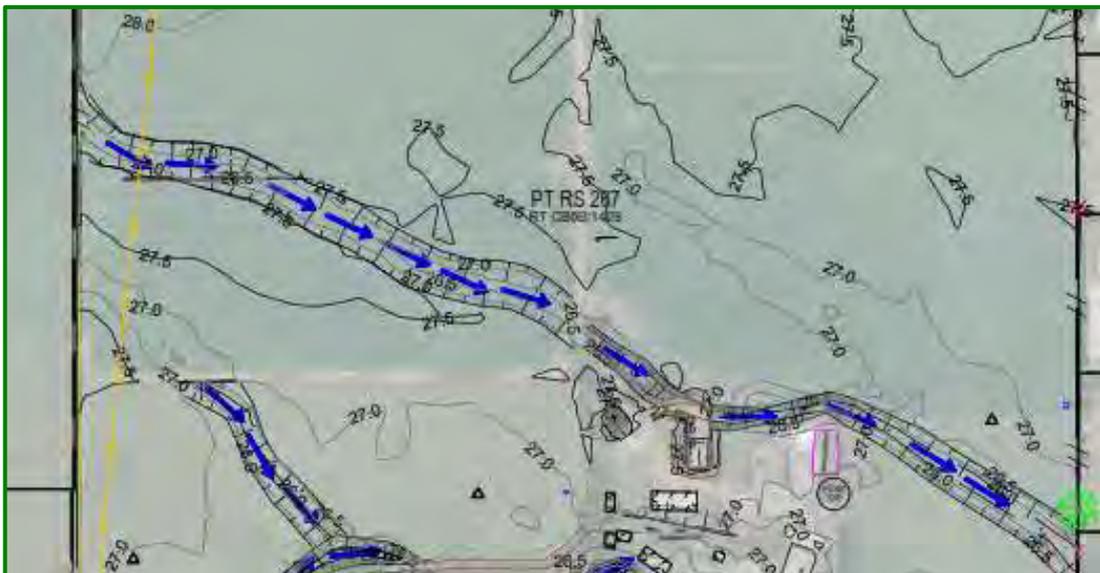
Figure 2 – Excerpt from Aurecon topographical site plans

The current northern overland flow channel has two distinct profiles. The topographical plan excerpt in **Figure 2** below shows the northern flow channel with different widths and bank steepness. Generally the contour lines show that the invert of the channel through the central portion matches in with the upstream and downstream inverts, indicating that the works completed over the years have not ‘filled’ the overland flow channel.

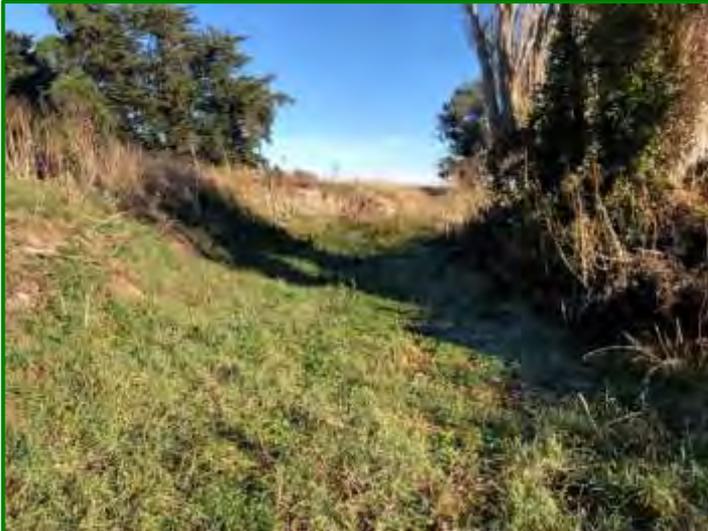
In the middle section where the overland flow channel crosses at the rear of the farm working yard area, it has steeper grassed banks with some vegetation on the northern side and some intermittent vegetation on the southern side, the base of the flow path is approximately 8-10m wide. There is no low flow channel present and no physical evidence of it having had any flowing water in it. See **Photos 1 and 2** below.

Photo 1 - Looking upstream from the eastern end of the central portion

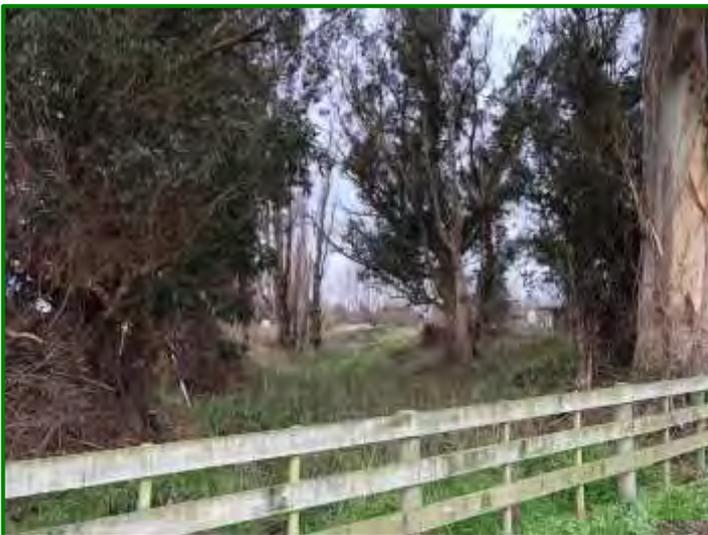
Photo 2 - Looking downstream at the central portion from the paddock

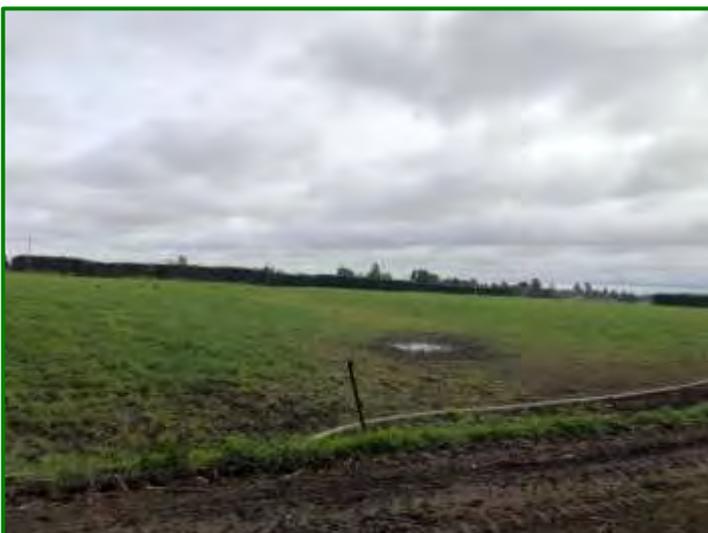
Upstream and downstream of this section the flow path is part of the grazed paddock and has a wide shallow batter. See **Photo 3** below.

Photo 3 - Looking upstream from the central portion to the paddock

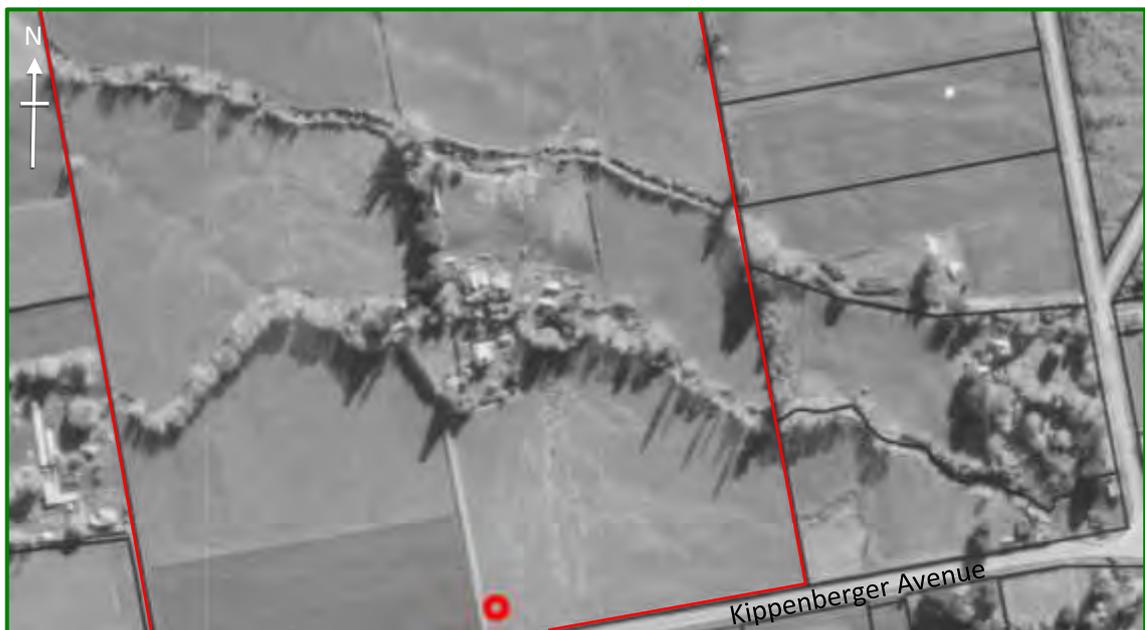
### 1963 - overall

The northern overland flow channel appears to be in the process of having adjacent trees removed from the southern side of the central portion. Upstream of the subject site, the trees have been removed and the channel graded over into a grassed overland flow path. The channel has two distinct rows of trees, generally 9-11m apart, which appear to be well established, and some are quite large. There is also evidence of other overland flow paths to the north and south of the tree lined northern flow channel, as typical for a braided river flood break out area.

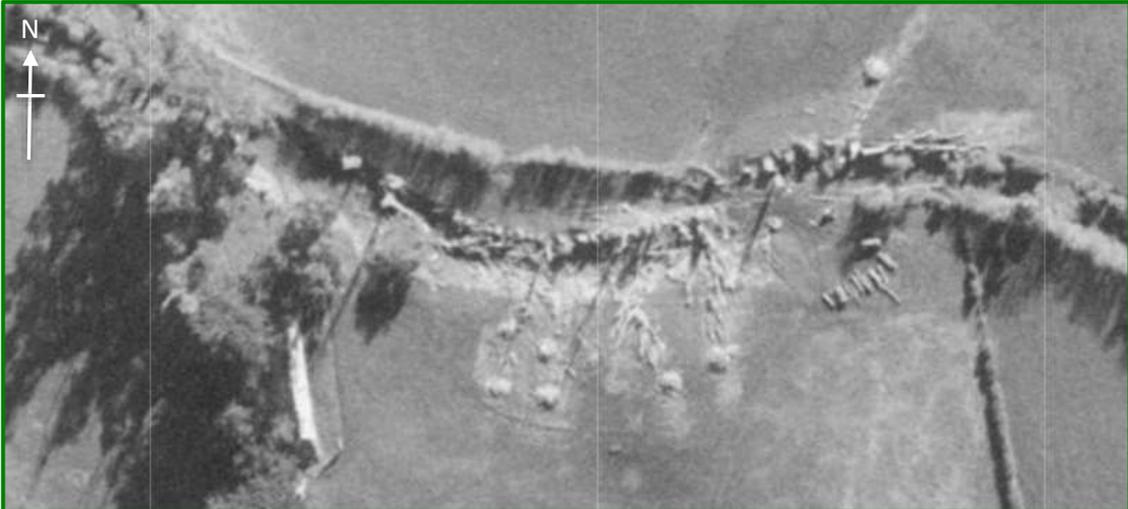
**1963 – close up of mid portion**

In the close-up view, piles of vegetation are evident, likely for burning, along with stacks of logs, indicating the size of the trees that had been removed.

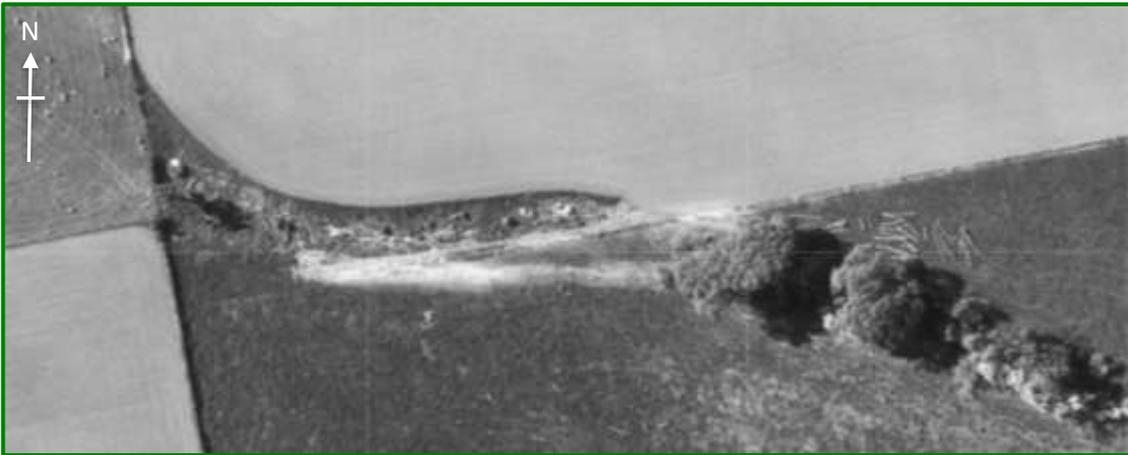
**1965 – close up of western portion**

The removal of trees has been completed with some large stumps evident, and some logs to the east of the cleared portion. With the tree canopy gone there does not appear to be a smaller defined low flow channel and the cross section is more that of an overland flow path than a drain. The white areas are likely to be soil/grass disturbance created by vehicle tracking.

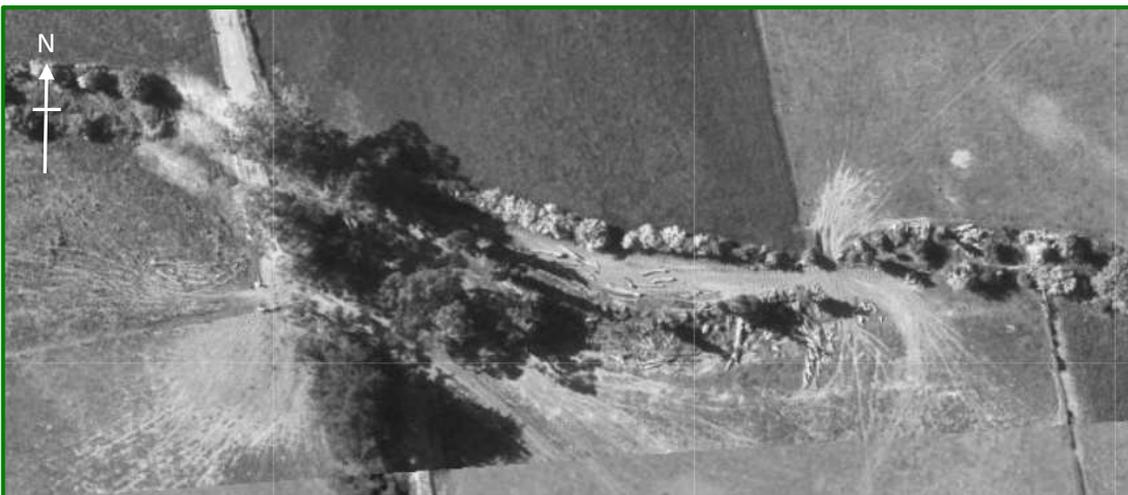
**1965 – close up of mid portion**

There is evidence of vehicle tracking along the base of the flow channel. This is likely to be related to the transport of the logs and the work occurring at the western portion. This also matches in with the current day where the flow channel base has a wide flat profile which can double as a vehicle accessway if required.

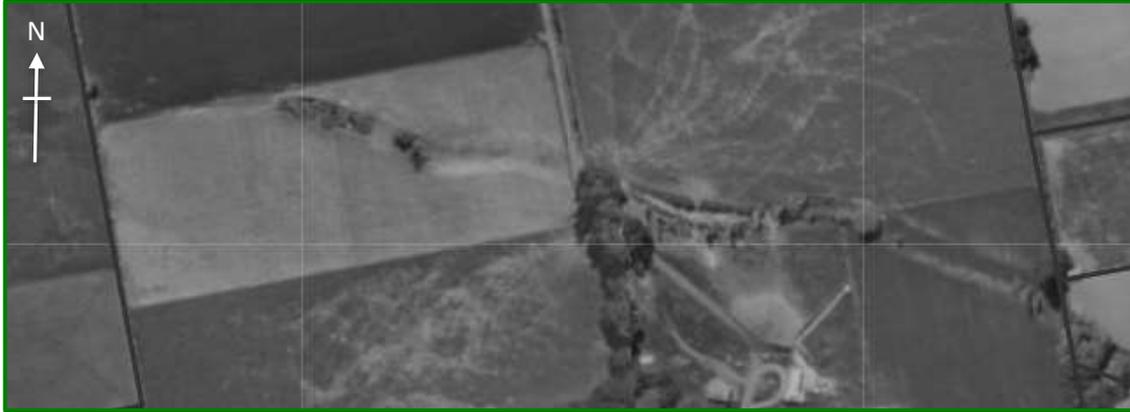
**1973 - overall**

Within the western half, only a small section still has some trees along the flow channel. The flow channel appears to be wide and shallow and has been grassed to form part of the pastureland. At the eastern most quarter, the trees have been removed. Two lighter strips of vegetation can be seen along the banks of the flow path. This is likely where the steeper banks have been flattened off by ploughing and tractor movements and replanting of grass has occurred, but it is still establishing.

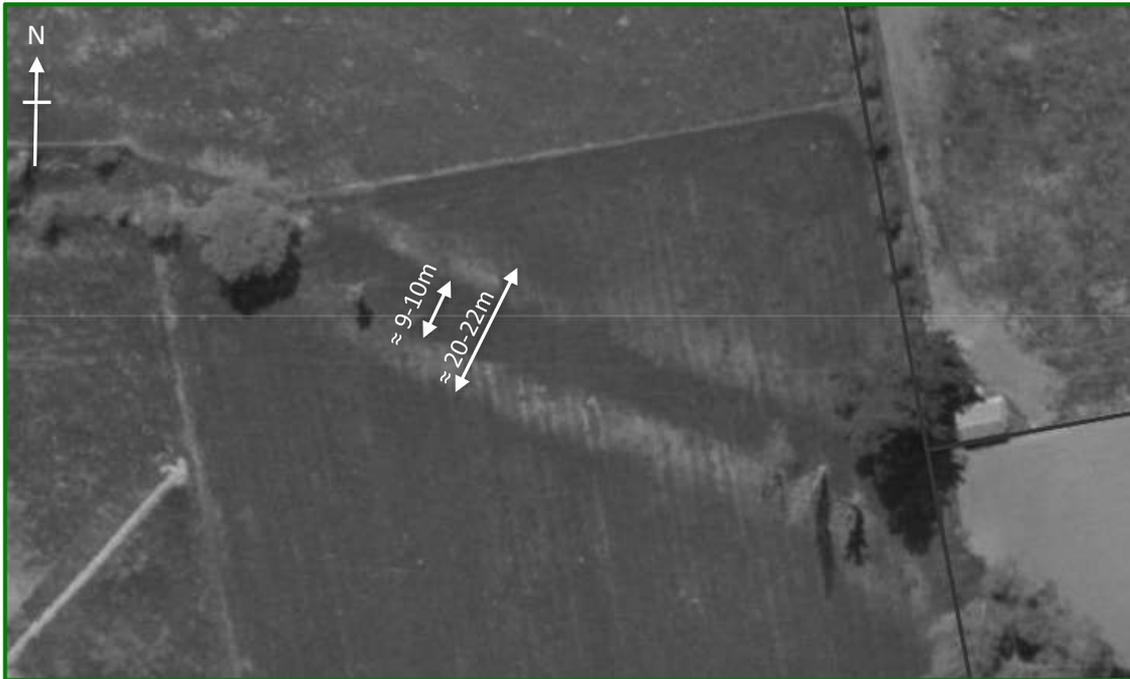
**1973 – close up of eastern most portion**

The line of ploughing/tractor movements at right angles to the flow channel show how the steeper banks will have been flattened off over the decades of pastoral farm use. Dimensions are included on this photo to give the viewer an idea of scale.

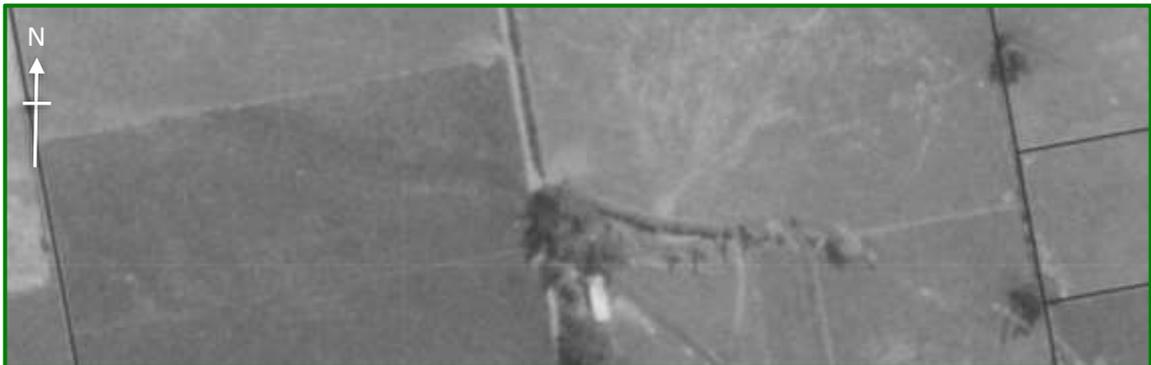
**1976 - overall**

All trees are now removed within the western half. The channel is difficult to see, likely because the pasture has an even growth pattern.

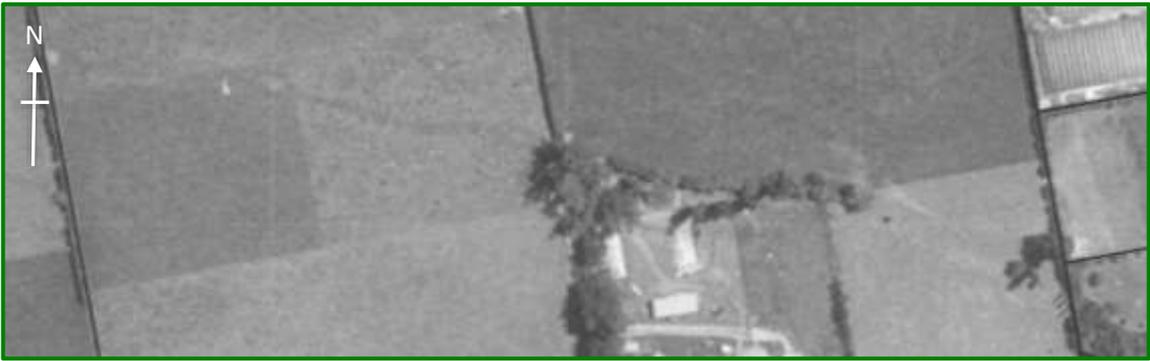
**1994 - overall**

No physical changes are apparent. The channel in the western half is more visible in this aerial than 1976, perhaps because of a rainfall event which has caused better grass growth in the channel.

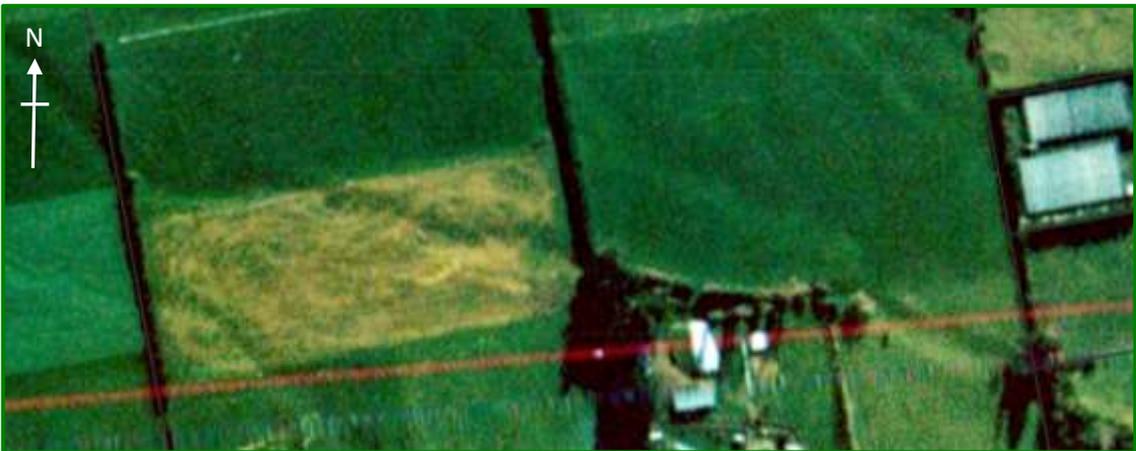
**1995 – overall**

As per 1994 aerial, western flow channel is more visible than 1976 due to better grass growth in the base.

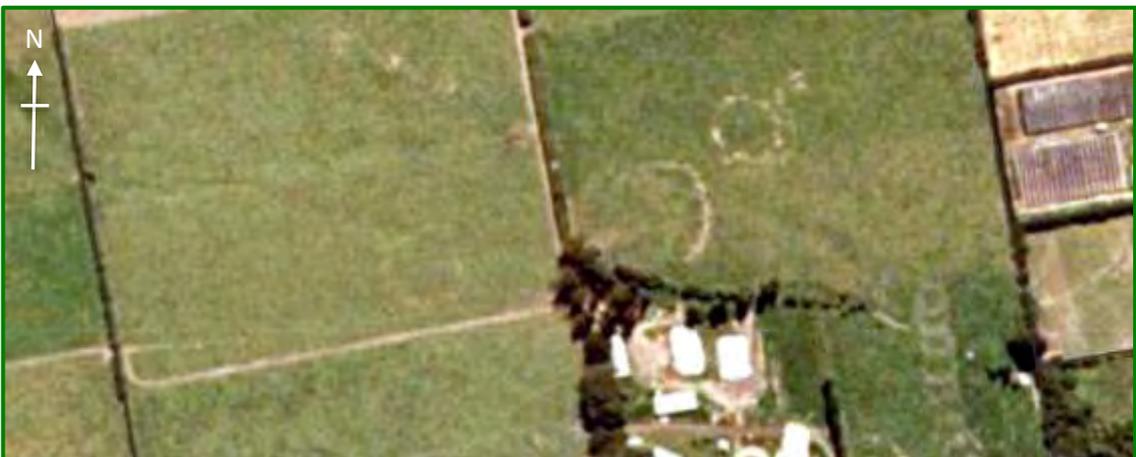
**2000 - overall**

No physical changes are apparent.

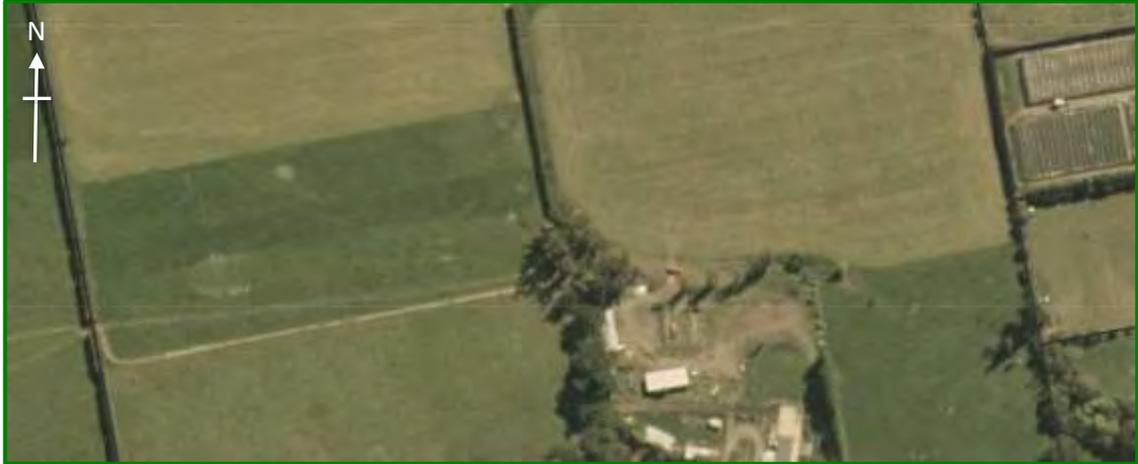
**2004-2010 - overall**

Trees on the northern side of the channel in the mid-section have been removed, along with some more trees in the eastern section. The channel is difficult to discern as there is a consistent grass cover across it.

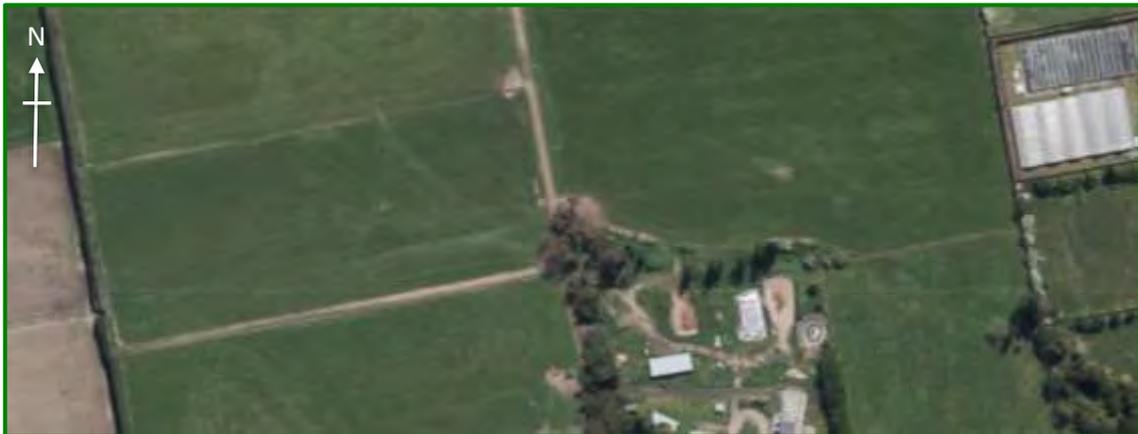
**2018 - overall**

No physical changes are apparent. The paddocks have a consistent and well-established grass cover resulting in the channel not being easily visible in this aerial.

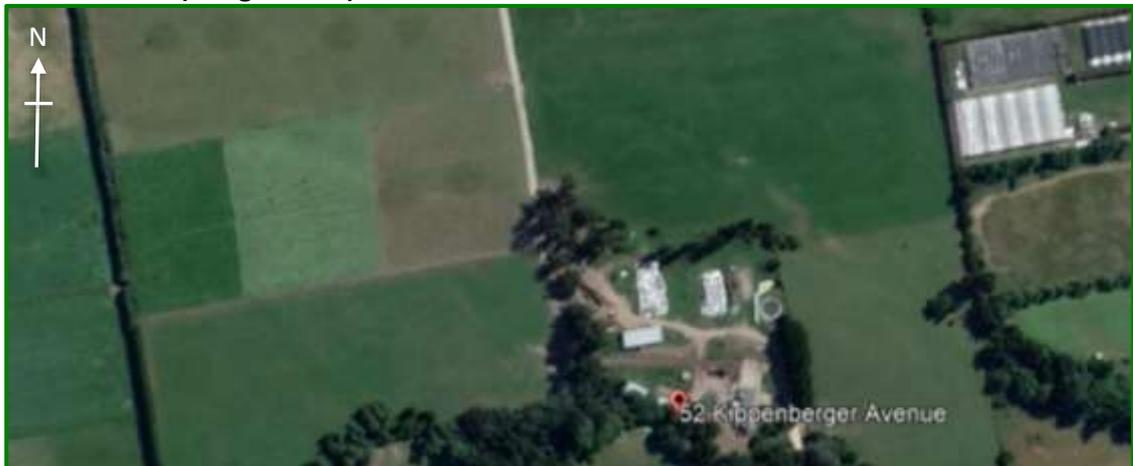
**2019 - overall (Google Earth)**

One year on, and the channel is more visible in this aerial due to the inconsistent paddock treatments and different times of the year.
