***Soil Contamination Risk  
Northern Overland Flow Channel  
Fill Risk Assessment***

***52 Kippenberger Avenue  
Rangiora***

*August 2021*

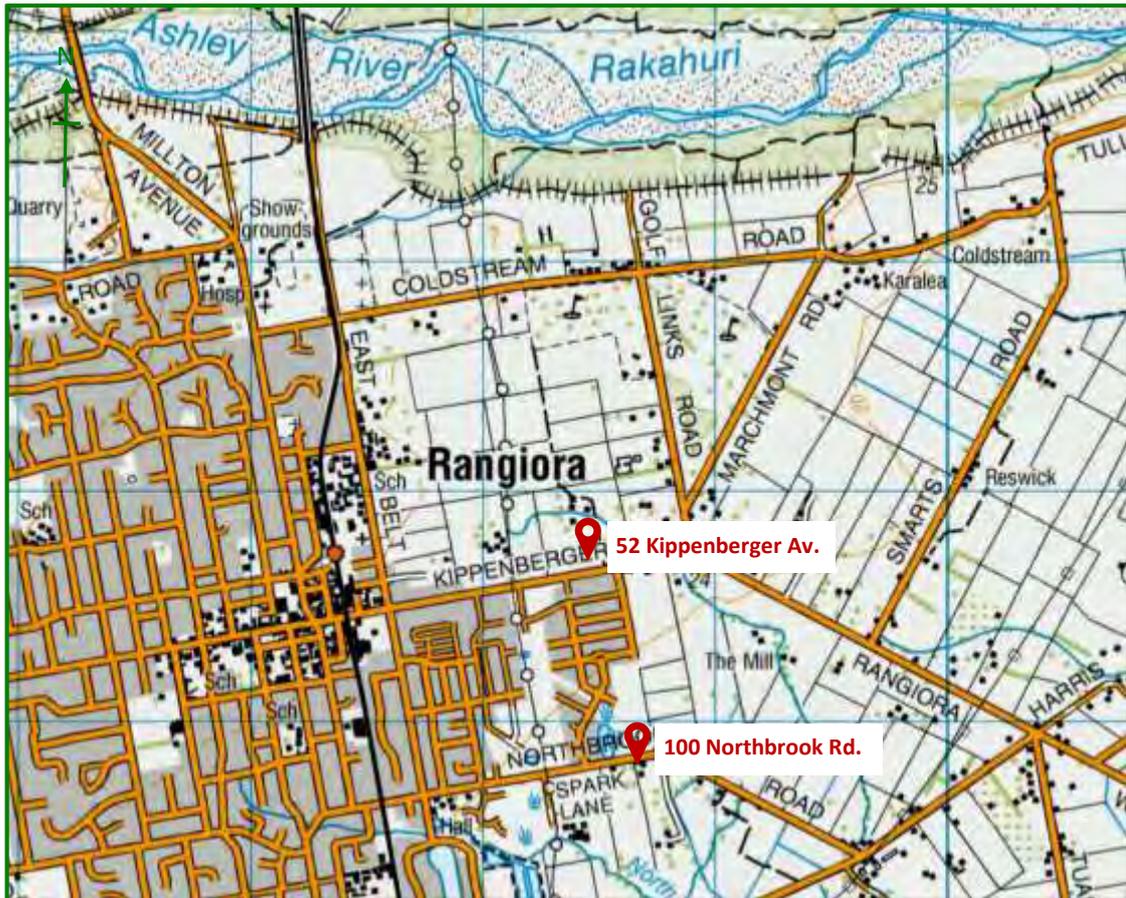
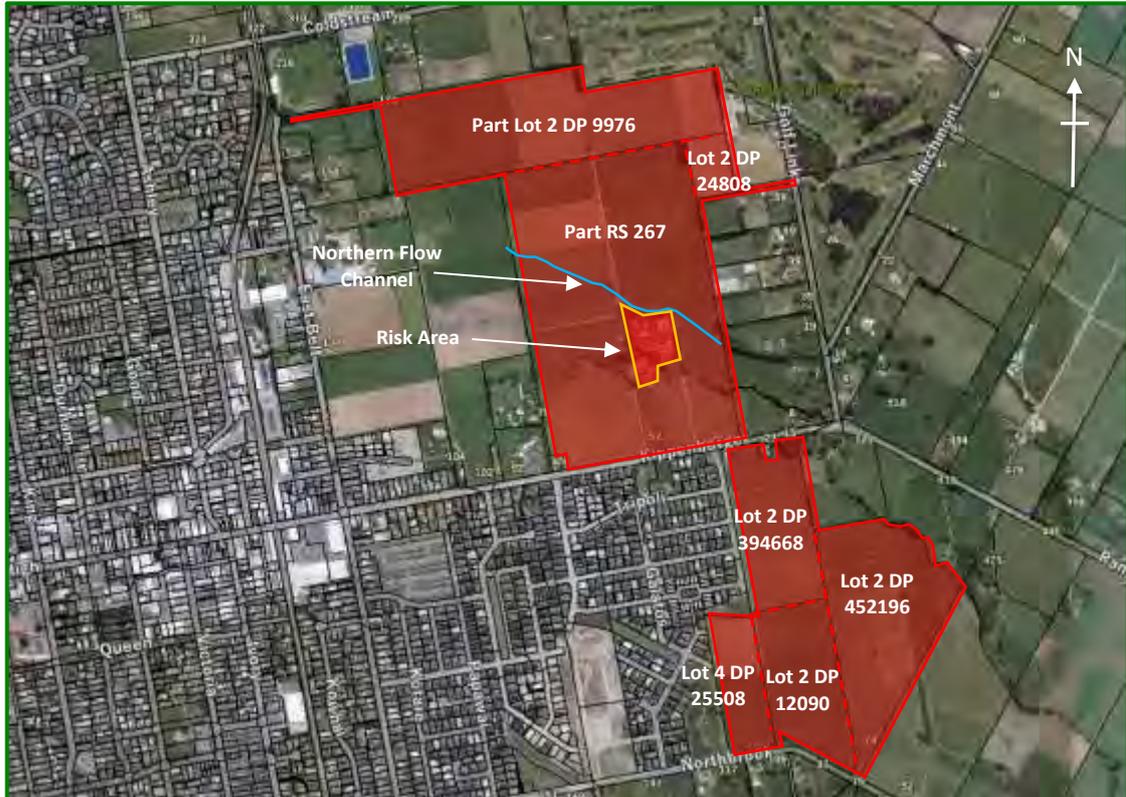
Figure 1 – Location Plan

The yellow outline is the risk area identified in the PSI, which includes the farm working yard area and the dwelling area. The northern flow channel which is the subject of this more detailed analysis crosses through Part RS 267 as indicated by the blue line on the location plan above.
