**To:** Aurecon **Date:** 1 October 2021  
**Attention:** Helen McLean **Ref:** 61714- 1B1  
**Subject:** **Papakura to Drury Stage 1B1 – Ecological Response to comments from the Auckland Council.**

This memorandum responds to the ecological comments by the Auckland Council on the Papakura to Drury South State Highway 1 Improvements – Stage 1B1 (EPA reference FTC00015).

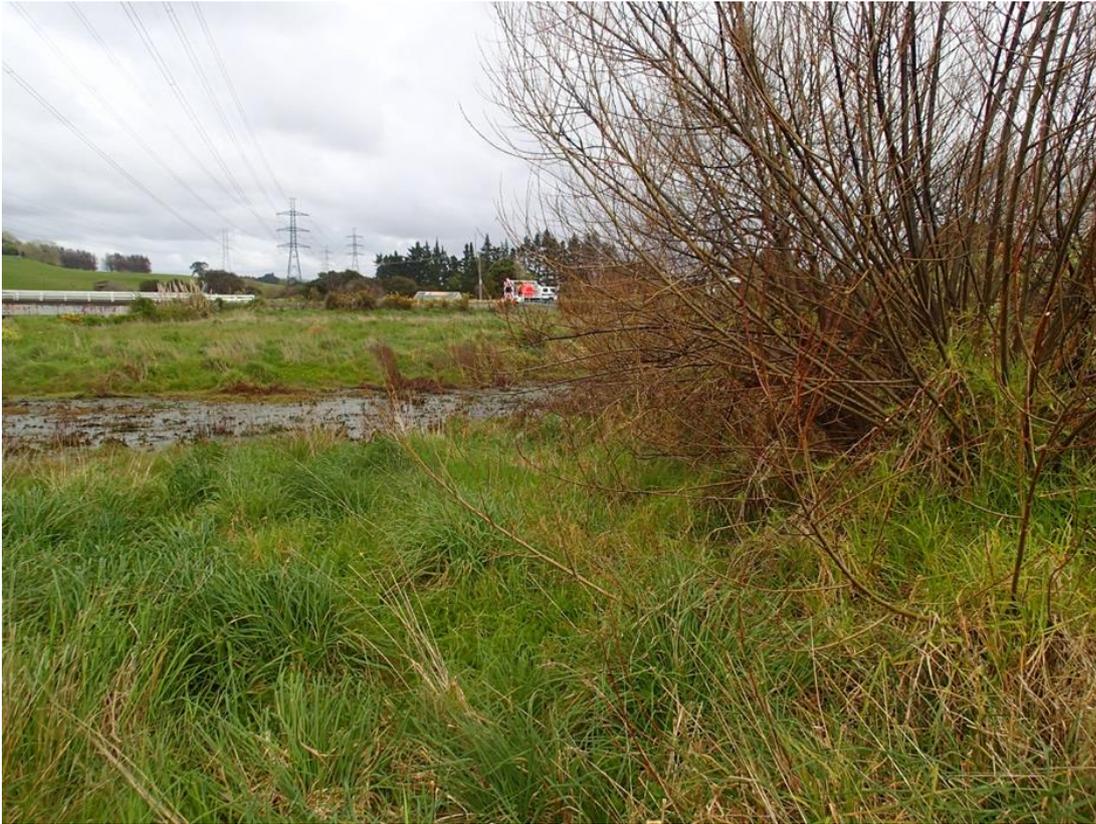
The potential for the pond as a significant habitat is poor. Over the four occasions that it has been checked, including 30 September 2021, the water levels have fluctuated from completely dry to over 0.6m deep. On the most recent site visit, the majority of vegetation within the pond was dead with a layer of filamentous algae overlying the vegetation (Photo 1). The site is subject to ongoing works by Watercare and Waka Kotahi; is bounded by the railway, SH1 and the access roads to the motorway; and has been and will be subject to a high level of disturbance. The ponding has been created by the recent access track for the Watercare works and a temporary culvert. Consequently the current habitats are highly variable in both form and function and although they meet the technical definition of a wetland with the majority of the vegetation exotic pest plant species the ecological value of the vegetation was assessed under the EIANZ criteria as negligible. The potential of the site if the pest plants were cleared and vegetation was enhanced with indigenous vegetation would be low i.e. providing limited ecological value other than a local habitat for tolerant native species, with very limited connectivity to other habitats (surrounded by transport infrastructure and electrical pylons).

There is currently little vegetation in the pond. In dryer months it was dominated by pasture weeds and water pepper. The vegetation surrounding the site is dominated by long grasses, and pest plant species (crack willow, gorse). No significant indigenous vegetation is present or will be lost through the activity, and no significant indigenous fauna have been observed or are expected to present at the site.

**Photo 1. Karaka Reserve pond / wetland and surrounding vegetation (30 September 2021).**

The earthworks will result in the loss of the majority of the pond under the batters for the motorway onramp.
